13.0 Naturita, Colorado, Disposal Site

The Naturita Disposal Site, inspected on July 10, 2003, was in excellent condition. Global positioning system (GPS) equipment was used to determine the coordinates of several incorrectly mapped site surveillance features. Noxious weeds persist at the site and require ongoing control. No requirement for a follow-up or contingency inspection was identified.

Figure 13-1. 2003 Annual Compliance Drawing for the Naturita, Colorado, Disposal Site

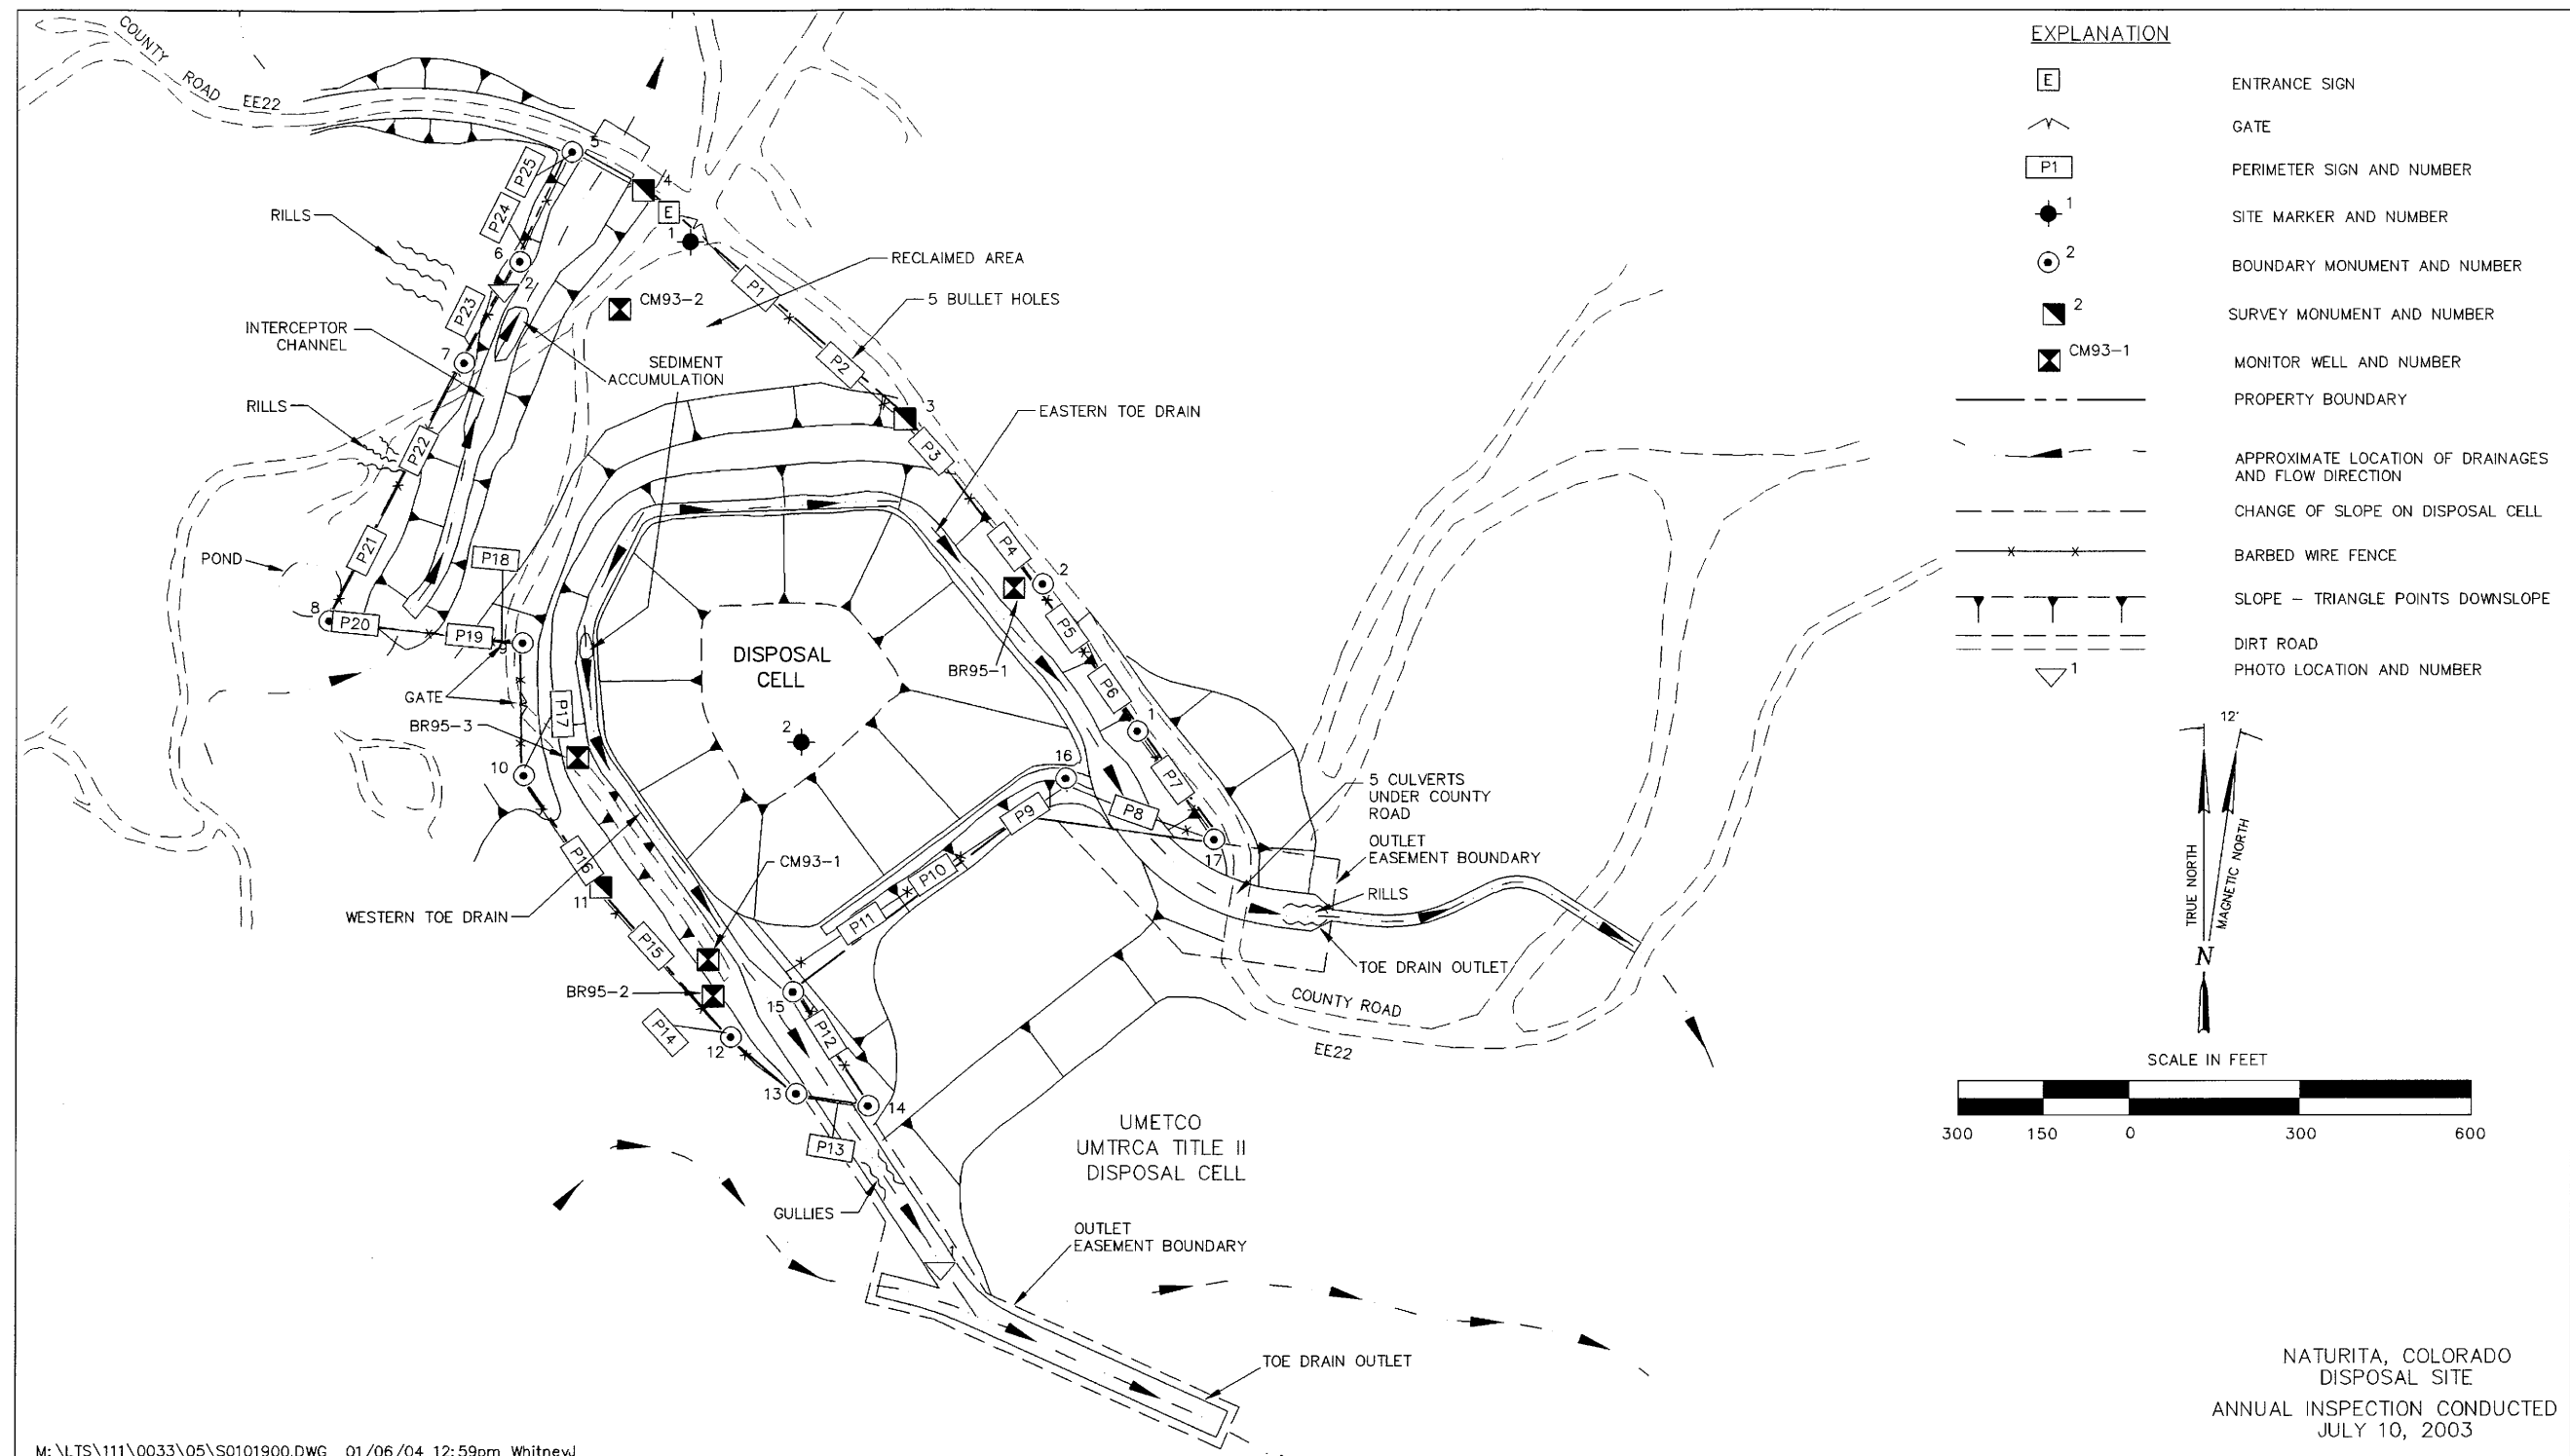
The site has 25 perimeter signs and one entrance sign. Perimeter signs are on galvanized steel posts approximately 5 feet inside the perimeter fence. One sign (P2) has bullet holes but was legible. The other signs were in excellent condition. Several perimeter signs on the west side of the site were incorrectly positioned on the inspection drawing and their actual coordinates were determined using GPS equipment; the site map was updated and Figure 13–1 shows the correct locations.

The site property boundary has 17 corners, which are marked by boundary monuments or survey monuments. Three survey monuments (SM–3, SM–4, and SM–11) are used in lieu of boundary monuments. Survey monuments were installed during site construction for survey control; boundary monuments were installed after completion of construction. All boundary and survey monuments were undisturbed and in good condition. The boundary monuments on the west side of the site were incorrectly positioned on the inspection drawing and their actual coordinates were determined using GPS equipment; the locations shown on Figure 13–1 are correct.

- 13A The U.S. Bureau of Land Management right-of-way permits for the toe drain outlets (the drains extend beyond the property boundary), originally set to expire in 2004, were modified as perpetual easements in 2003. The surveyed easement boundaries are shown on Figure 13–1.

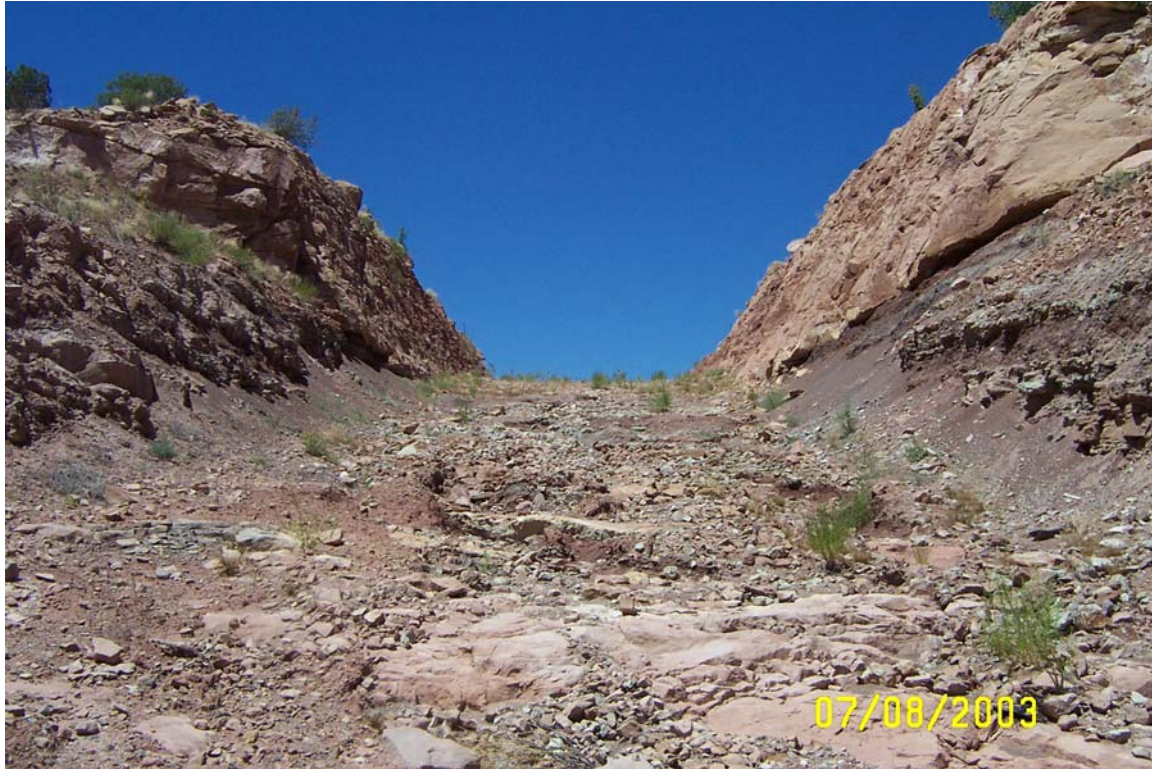
Toe Drains and Outlets—Two riprap-filled toe drains collect water from the cell side slopes and divert it to the southeast. The toe drain on the western side of the cell exits through a channel quarried through the wall of the Burbank Pit and into a deep canyon leading to the San Miguel River. Some sediment has accumulated in the upper end of the western toe drain. The eastern toe drain exits through the adjacent UMETCO UMTRCA Title II disposal site and crosses beneath County Road EE22 through five culverts. Some erosion of loose material has occurred in the toe drain outlets, but the underlying sandstone bedrock (PL–1) limits further erosion. Patches of noxious weeds (halogeton and Russian knapweed) were found adjacent to the toe drain outlets; the weeds will be sprayed with herbicide in 2004.

NAT 07/2003. PL-1. Erosion in the western toe drain outlet channel.

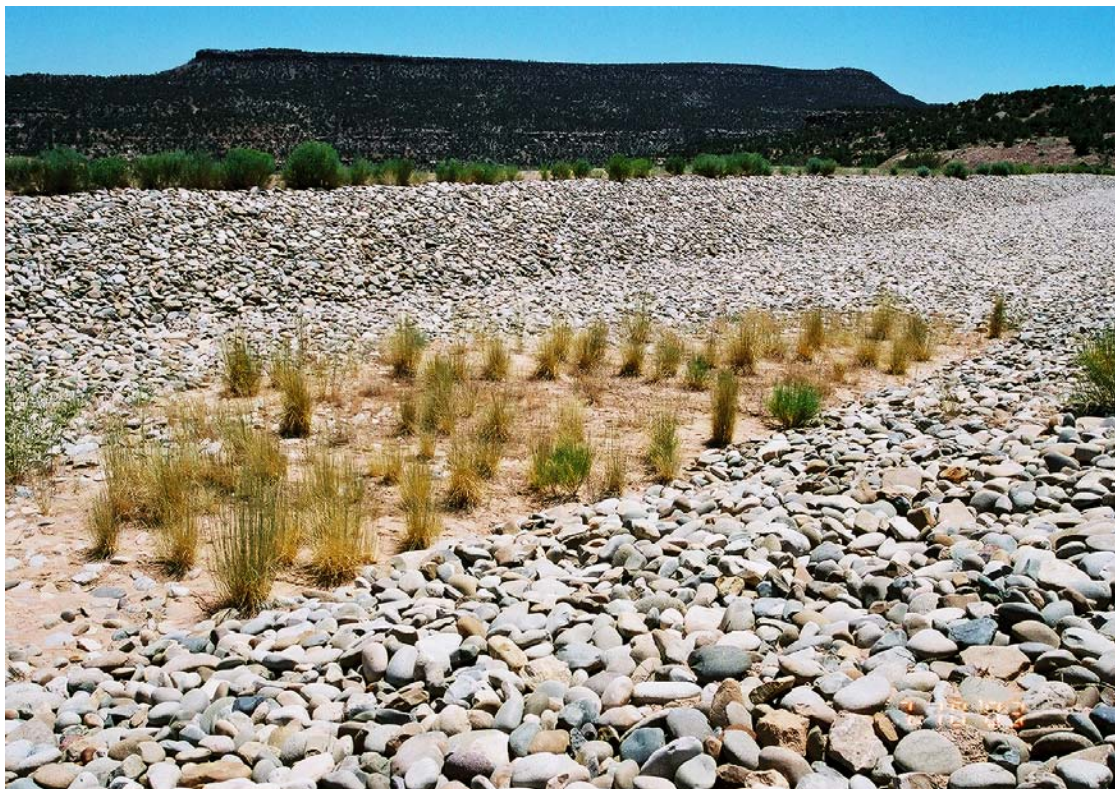
Interceptor Channel—A riprap-armored interceptor channel, northwest of the disposal cell, diverts storm water and snowmelt run-on to the east across County Road EE22. Some erosion has occurred outside the property uphill from perimeter sign P23 resulting in deposition of sediment in the channel (PL–2). Otherwise, the channel was in excellent condition and the accumulated sediment does not impair the function of the channel. No culvert was installed where the channel crosses the road, so the road could be damaged when storm water exits the channel. Halogeton was observed near the upstream end of the channel and will be sprayed with herbicide in 2004.

NAT 07/2003. PL-2. Sediment accumulation in the interceptor channel.
